Subject: Response to Safety and Enforcement Division (SED), 2015 Electric Audit Report of PG&E's Transmission Line Eureka Headquarters; CPUC ID: TA2015-001.

## Section I

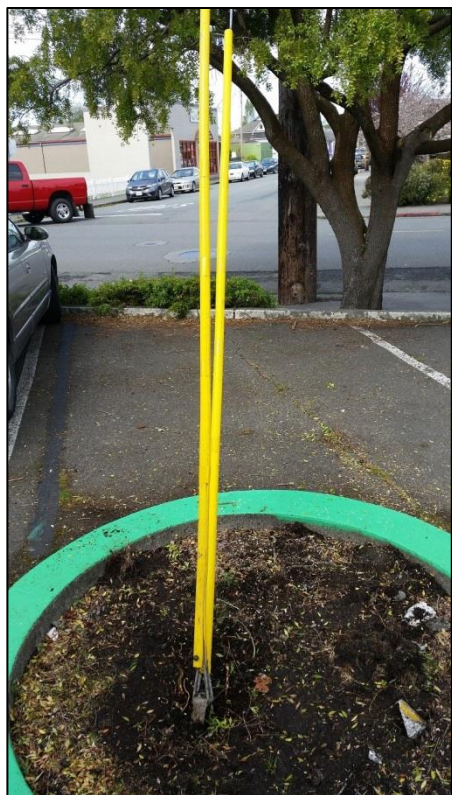
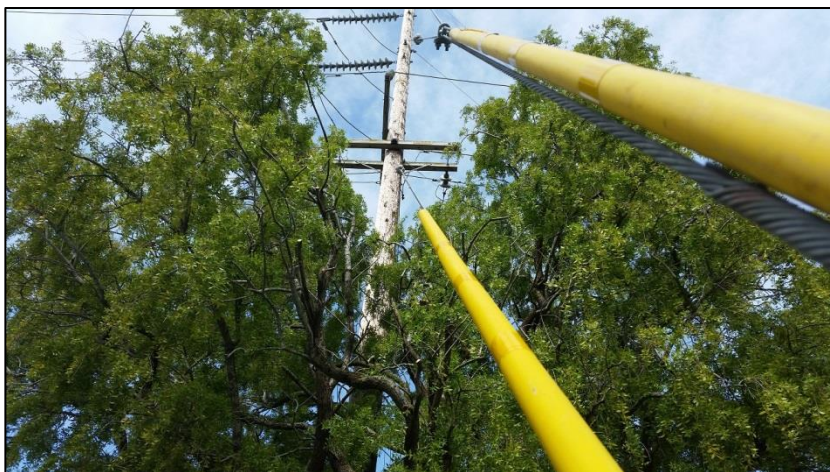
<b>B.</b>	<b>Circuit:</b> Arcata – Humboldt
	<b>Structure No.:</b> 7/7
	<b>Previous Visit by PG&amp;E:</b> 3/21/14
	<b>Date Visited by CPUC:</b> 2/24/15
	<b>Explanation of Violation(s):</b>
	<p><b><u>Damaged Guy Guard and Guy Wire Contact Above Insulator</u></b></p> <p>GO 165, Section IV, Transmission Facilities, states in part:</p> <p style="padding-left: 40px;"><i>Each utility shall prepare and follow procedures for conducting inspections and maintenance activities for transmission lines.</i></p> <p>GO 95, Rule 56.7-B, Anchor Guys, states in part:</p> <p style="padding-left: 40px;"><i>In order to prevent trees, buildings, messengers, metal-sheathed cables or other similar objects from grounding portions of guys above guy insulators, it is suggested that anchor guys be sectionalized, where practicable, near the highest level permitted by the Rule.</i></p> <p>GO 95, Rule 31.1, Design, Construction and Maintenance, states in part:</p> <p style="padding-left: 40px;"><i>Electric supply and communication systems shall be designed, constructed, and maintained for their intended use, regard being given to the conditions under which they are to be operated, to enable the furnishing of safe, proper, and adequate service. For all particulars not specified in these rules, design, construction, and maintenance should be done in accordance with accepted good practice for the given local conditions known at the time by those responsible for the design, construction, or maintenance of communication or supply lines and equipment.</i></p> <p>The guy guard was damaged and vegetation was in contact with the guy wire above the insulator.</p>

<p>PG&amp;E Response: On Thursday, February 26, 2015, at 11:09 AM, Ms. Yoko Williams sent an email message to Mr. Raymond Cho letting him know that PG&amp;E cleared the vegetation from touching the guy wires above the insulators and that the damaged guy guard had been replaced. Please see the photos attached below showing the completed work.</p> <p>To prevent recurrence, the Transmission Line supervisor in Humboldt conducted a tailboard with crew members who perform patrols and inspections to reinforce the requirements to identify vegetation touching guy wires above the insulator and also damaged guy guards and the steps that need to be taken to mitigate such items.</p>
